**The Influence of Temperature Change on Crack Openings in a Reinforced Concrete Shell of Pressure Piping at Kruonis Pumped Storage Power Plant**

**Raimondas Šadzevičius, Vincas Gurskis, Rytis Skominas, Tatjana Sankauskienė**

Institute of Hydraulic Engineering, Faculty of Water and Land Management, Aleksandras Stulginskis University, Kaunas Universiteto 10, 53361 Akademija, Kaunas dist., Lithuania

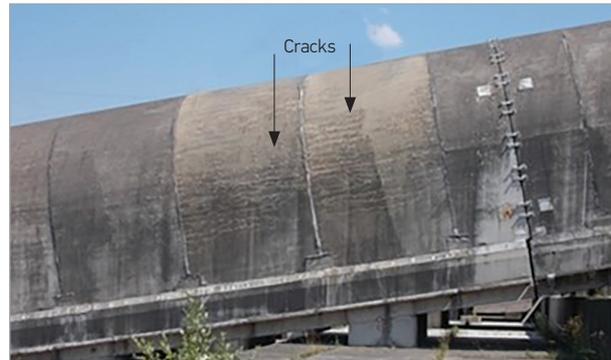
**Fig. 2**

**Piping cracking.** The surface of the top and the side-walls of the piping are covered with dust and are considerably darker than the bottom surface.

This layer of dust results in humidity from precipitations, which needs more time to evaporate, and in the darker surface, which heats up more because of sun radiation.

This is the cause of different temperature deformations and stresses at the top and the bottom of the piping inasmuch as outside and inside the piping.

Cracking on the surface of concrete due to differences in temperature is shown in Figure 2.

This cracking could be explained by an unsuitable treatment of concrete in the process of solidification (an over-dried surface layer of concrete increases shrinkage deformations) and also by different temperature deformations in the inside and outside surfaces of the pipes, as cracks open on the outside surface when, due to negative temperature during winter time, it becomes cold and shrinks. It was established (Figure 3) that, when there is a difference of  $11^\circ\text{C}$ , shrinkage deformations, which match limit ductility of concrete, appear; and when there is a bigger difference between temperatures, longitudinal cracks open on the surface of concrete. The temperature dropdowns in the walls of the pressure piping, when the temperature on the inside of the pipe is  $+4^\circ\text{C}$  and on the outside  $-20^\circ\text{C}$ , are shown in Figure 3.

Cracking in the surface of concrete at the top of the pressure piping. Source: taken by authors

In order to prevent water from passing through the openings on the surface of concrete, it is necessary to perform the following works: to wash the surface of the pipes, to remove the plants, to seal the joints of

the pipes and repair other damages of the surface, to prime the surface and to cover it with a bright material which is resistant to temperature deformations (elastic), hydrophobia, CO<sub>2</sub> and ultraviolet light, which passes through water vapour so that humidity could disappear from concrete. Part of the third piping was repaired over the period of May to June in 2014 by removing the

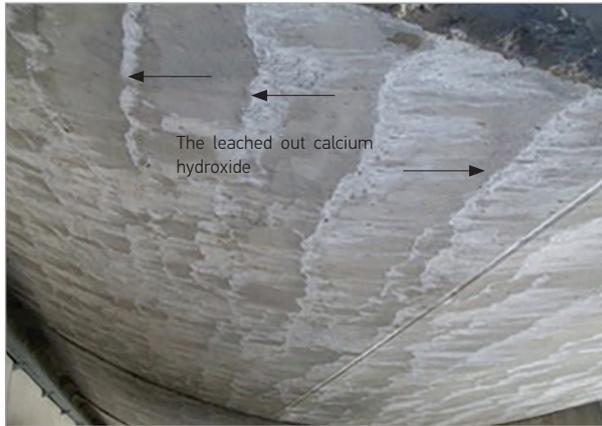
**Fig. 4**

Longitudinal cracks during winter time caused by circular temperature deformations are shown in Figure 4.

Distressed concrete in the bottom part of the surface in section 17 of the third pipe: seeping water leaches out calcium hydroxide. Source: taken by authors

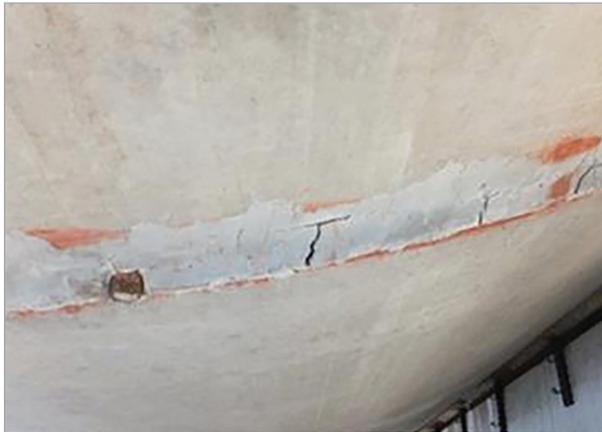
**Fig. 6**

**Temperature deformations in piping sections.** It was established during the visual investigation that certain joints connecting the piping sections were sealed with unsuitable mortars, which were cracked and did not ensure joints tightness (Figure 6).

Joints of the piping sections sealed with cement mortar, which is cracked. Source: taken by authors

- 1 To renovate the joints in compensation for temperature deformations so that their values would correspond to those of the design;
- 2 To renovate the worn protective cover of the inclusive steel details and other steel elements;

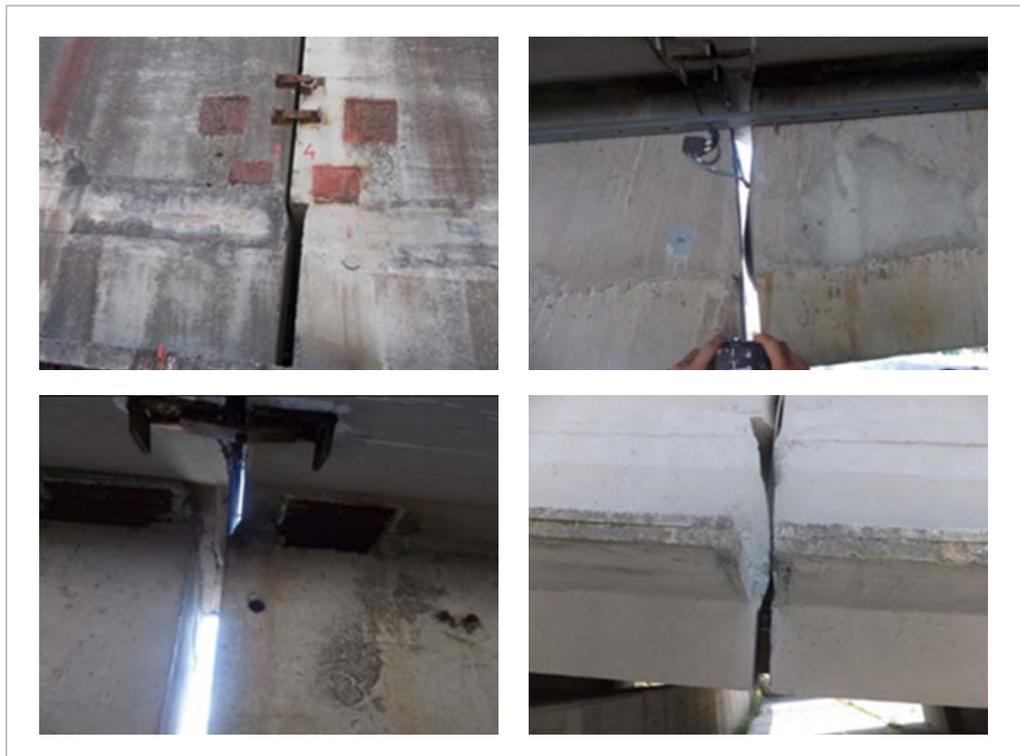
**Fig. 7**

Concrete of different elements in the compensators of the pressure piping is in contact or almost in contact (Figure 7). The reason of this defect is concrete shuttering, which was inaccurately built or damaged during concrete construction works. It is indispensable to eliminate the defects by increasing the width of joints in order to match the one specified in the design. Over the last few years, maintenance works have been performed: spaces have been widened by cutting out the concrete in contact. Steel details in the compensators of the piping are damaged by corrosion.

Concrete of different elements in the compensators of the pressure piping is in contact or almost in contact. Source: taken by authors

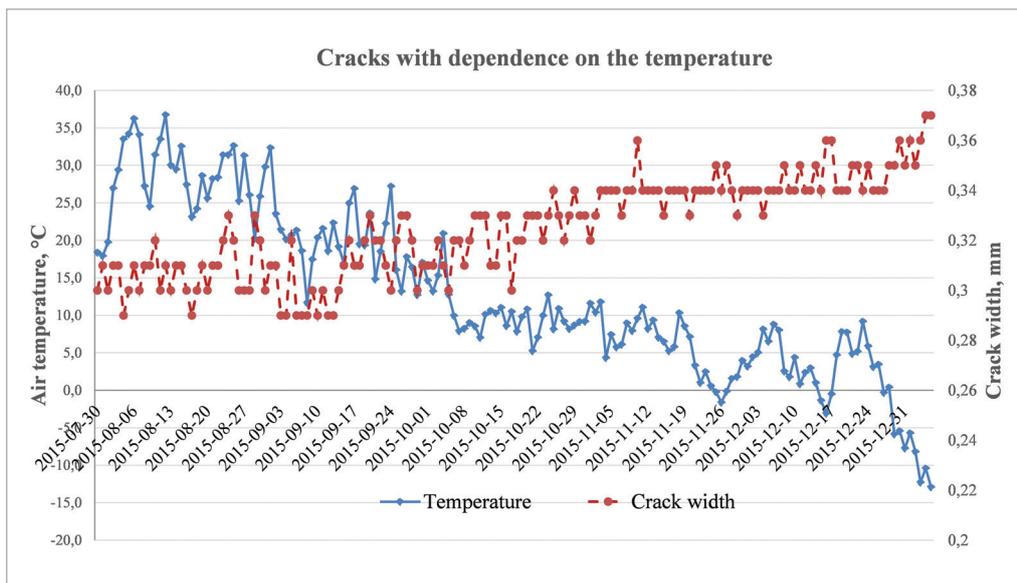
**Fig. 9**

The surveillance of crack width in the pressure piping of Kruonis PSPP has been performed since 1997. Figure 9 illustrates more detailed measurements and the analysis of change of crack width in level 33 of the first piping from July 30, 2015 to January 05, 2016. Accord-

ing to research results presented in Figure 9, the width of cracks in level 33 of the first piping increases in negative temperature. The observation carried out from July 30, 2015, to January 05, 2016, showed that the width of cracks had increased from 0.34 mm to 0.37 mm.

The change of crack width in level 33 of the first piping during the period of observation from June 30, 2015, to January 5, 2016. Source: drawn by authors

- 3 According to research results presented in Figure 9, the width of cracks in level 33 of the first piping increases in negative temperature. The observation carried out from July 30, 2015, to January 02, 2016, showed that, in negative temperature, the width of cracks had increased from 0.34 mm to 0.37 mm.

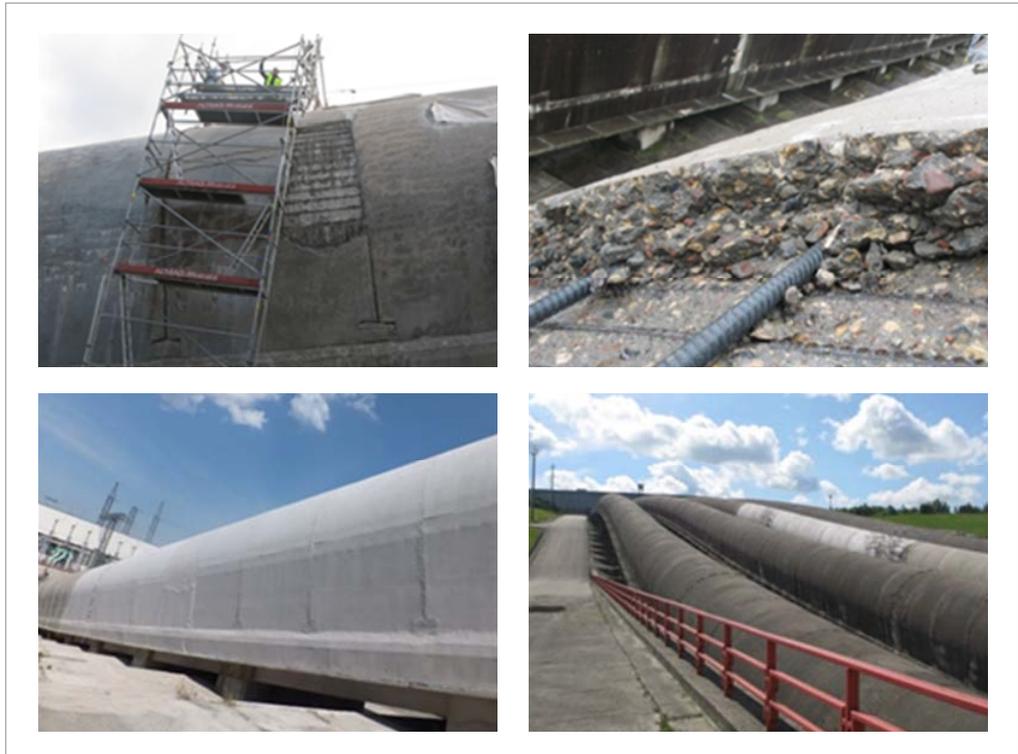
**Fig. 10**

Maintenance and painting of the third part of the piping.  
Source: taken by Lietuvos energija (photo of R. Vileikis)

cracked concrete up to reinforcement and replacing it with a new mixture of concrete. After the solidification of concrete, the surface was painted in white colour (Figure 10). Concrete of several neighbouring sections in the piping was also painted.

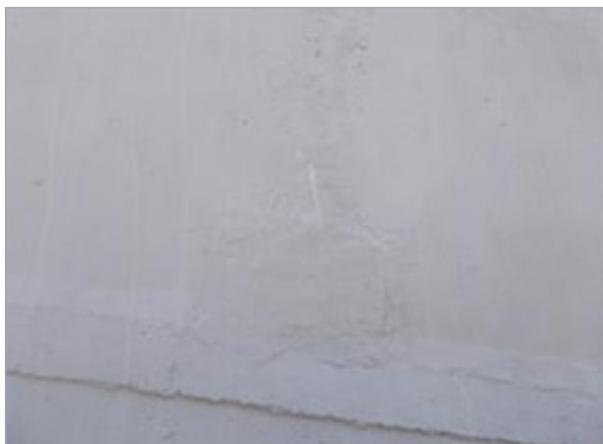
**Fig. 11**

We consider that the repair by removing cracked concrete would not be reasonable, as it requires a lot of time and financial costs. Besides, it would not stop water from passing into concrete: leaching out of  $\text{Ca}(\text{OH})_2$  was observed in the repaired and painted area of concrete (Figure 11).

Inconsiderable leaching out of  $\text{Ca}(\text{OH})_2$  in the repaired and painted part of the third piping. Source: taken by authors

Negative impact of temperature deformations could be reduced by installing piping insulation and covering the surface of the pipes with an elastic, hermetic material, e.g. a sprayed bicomponent system – polyurethane foam covered with acrylics compounds on top with a low level of solar energy absorption.
