**The Influence of Temperature Change on Crack Openings in a Reinforced Concrete Shell of Pressure Piping at Kruonis Pumped Storage Power Plant**

**Raimondas Šadzevičius, Vincas Gurskis, Rytis Skominas, Tatjana Sankauskienė**

Institute of Hydraulic Engineering, Faculty of Water and Land Management, Aleksandras Stulginskis University, Kaunas Universiteto 10, 53361 Akademija, Kaunas dist., Lithuania

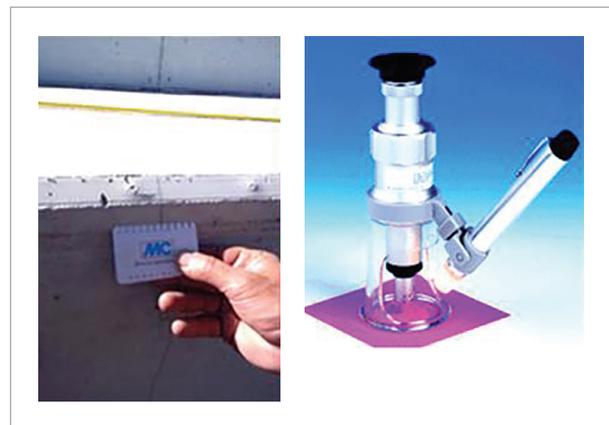
**Fig. 1**

The illustration of measurement of crack width using Elcometer 143 Crack Width Ruler and a microscope Elkometer 7220. Source: taken by authors

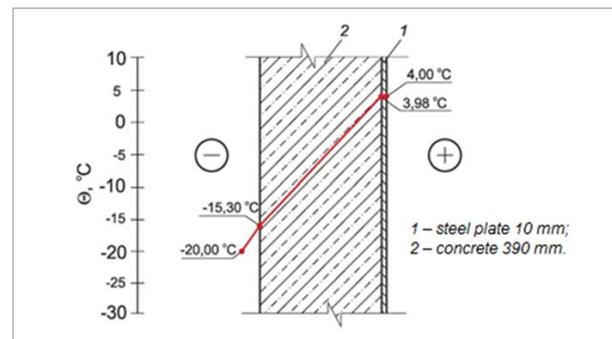
**Fig. 3**

This cracking could be explained by an unsuitable treatment of concrete in the process of solidification (an over-dried surface layer of concrete increases shrinkage deformations) and also by different temperature deformations in the inside and outside surfaces of the pipes, as cracks open on the outside surface when, due to negative temperature during winter time, it becomes cold and shrinks. It was established (Figure 3) that, when there is a difference of  $11^\circ\text{C}$ , shrinkage deformations, which match limit ductility of concrete, appear; and when there is a bigger difference between temperatures, longitudinal cracks open on the surface of concrete. The temperature dropdowns in the walls of the pressure piping, when the temperature on the inside of the pipe is  $+4^\circ\text{C}$  and on the outside  $-20^\circ\text{C}$ , are shown in Figure 3.

Temperature changes in the surface layer of concrete at the top of the pressure piping. Source: drawn by authors

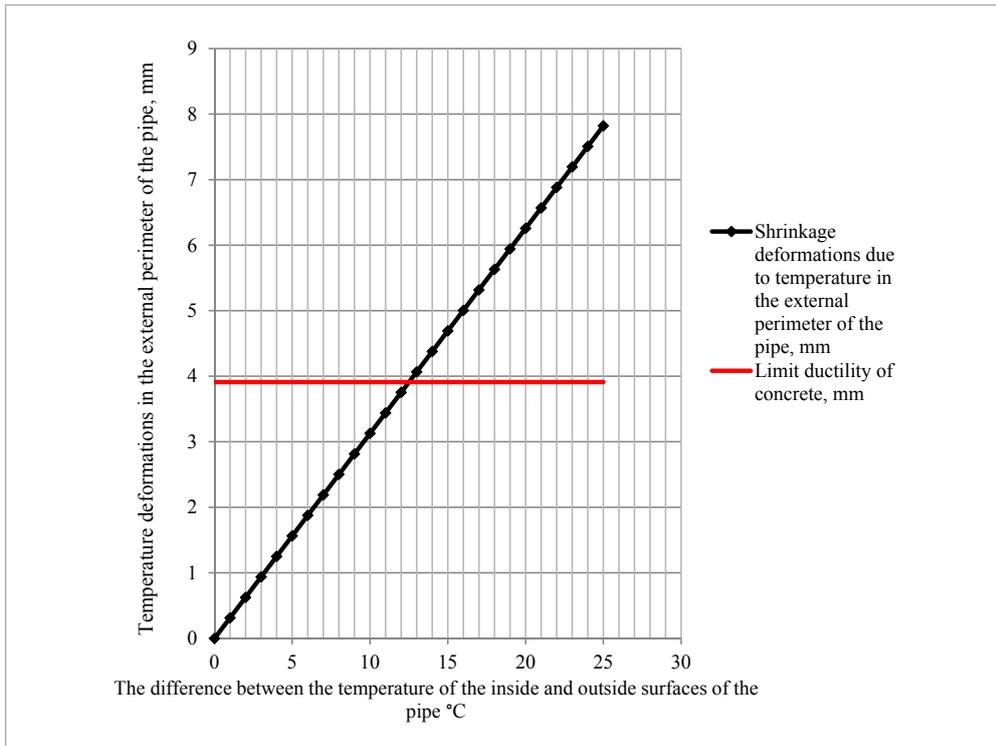
**Fig. 5**

Due to temperature deformations, tensile stresses, which surpass the limits, appear in the concrete (Figure 5).

Such causes of cracking in a pipe are not foreseen in the design, and the joints of longitudinal temperature deformations are not installed.

Deformations caused by differences in temperature. Source: drawn by authors

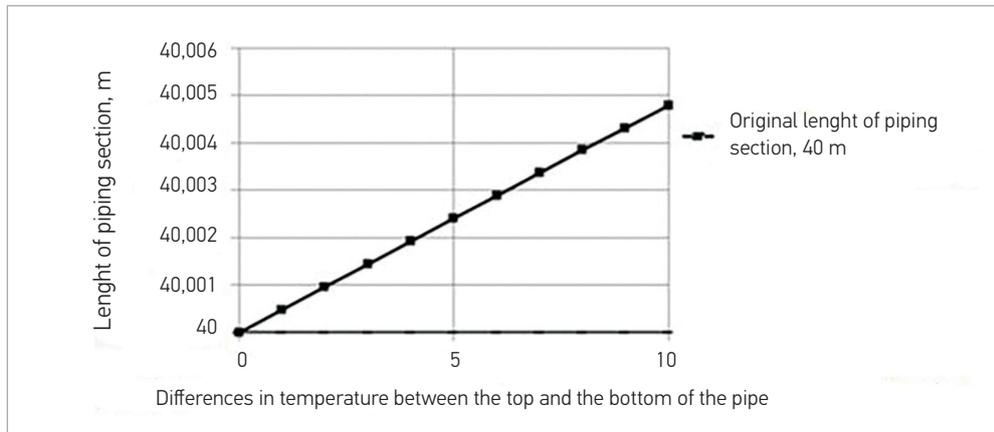
**Fig. 8**

Theoretical calculations (according to formula 1 and 2) showed that if the sun radiation created a difference of 10°C between the temperature at the top, which is dark and dusty, and the bottom of the piping, the top layer of 40 m long piping sections would become longer by 4.8 mm and the entire 840 m long piping would become longer by 100.8 mm. Due to different temperature deformations at the top and the bottom of the piping, there is a possibility of additional stresses in the compensators. Temperature deformations along the piping section are shown in Figure 8.

Temperature deformations along the piping sections when the difference between temperatures is 10°C. Source: drawn by authors
